The new Minnesota smart bridge

Kistler helps avoid desasters like the August 1, 2007 collapse by providing vital parts of the new bridge's early warning and security system.

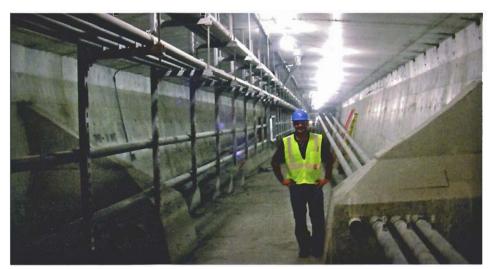
In the hollow space under the deck MME installed and wired 12 accelerometers Type 8310B2, each one at the midpoint of the girders, for constant vibration monitoring. A further 14 accelerometers will be used for modal analyses. The Kistler equipment is part of the first US smart bridge's impressive safety system.

The replacement bridge consists of separate north and south lanes supported by common piers. Each lane has three main spans composed of two hollow concrete box girders. Twelve Type 8310B2 accelerometers are used to monitor the vibration at the mid point of each concrete box girder. Accelerometer

cables ranged in length from 10 to 39 meters. The remaining 14 accelerometers are used for periodic modal studies.
